U.S. Department of the Interior
National Park Service

Inlets of the Southeast Region National Seashore Units:

Effects of Inlet Maintenance and Recommended Action

by C.W. Shabica, S.V. Cofer-Shabica, S.L. Boom and D.E. Anderson

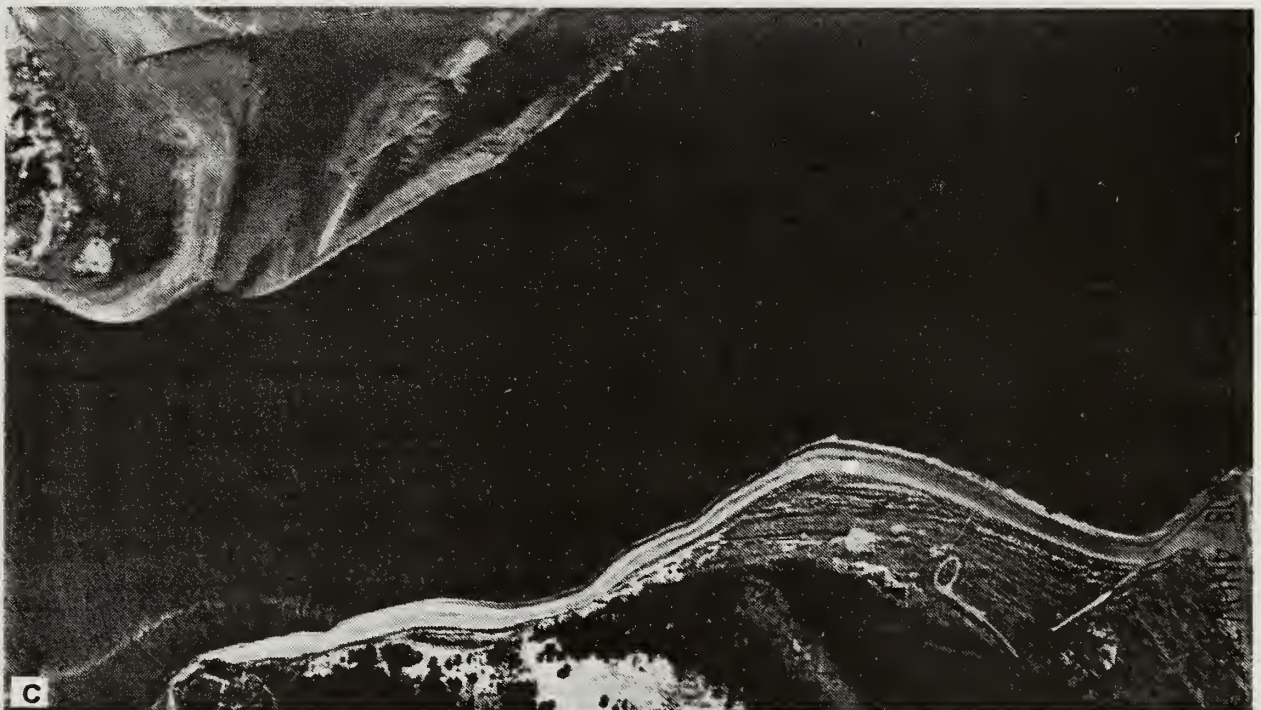
Fig. 9. Comparison of (a) pre-project [1870] and (b) evolved [1970] bathymetry, St. Marys Inlet, Georgia [Pope, 1991]. (c) Aerial Photo, 4 November 1971.
